The Emilia-Romagna earthquake: Damages to precast/prestressed reinforced concrete factories

A. Marzo*, G. Marghella**, M. Indirli***

Keywords: precast structures, factories constructions, seismic damages, Emilia Romagna earthquake.

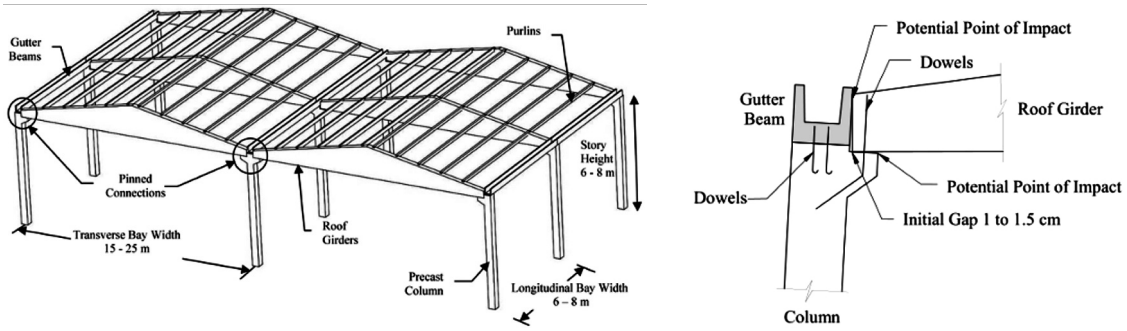
For example, after the January 17th, 1994 Northridge earthquake [Los Angeles, California, USA, M_W 6.7, see EERI, 1994], several parking lots suffered widespread damage or collapse. Among others, a typical example was the Cigna Garage, a multi-storey assemblage of precast and in situ cast elements (Fig. 1), located at a distance of approximately 5.5 km from the epicentre (the closest recording station measured peak values of 0.47g, horizontal, and 0.30g, vertical). The building connections failed, due to loss of bearing of supporting elements [Bonacina, Indirli & Negro, 1994]. The Northridge earthquake clearly demonstrated the deficiencies in pre-1971 (i.e. the watershed date of the M_W 6.6 San Fernando seismic event, which struck California in the same year) designed r.c. (including p/p.) structures. A large-scale revision of the code standards was carried out for various types of buildings in 1973, 1975, and after.

Fig. 1. *Cigna Garage damaged by the 1994 Northridge earthquake (Bonacina, Indirli & Negro, 1994).*
Garage Cigna danneggiato dal terremoto di Northridge del 1994 (Bonacina, Indirli e Negro, 1994).

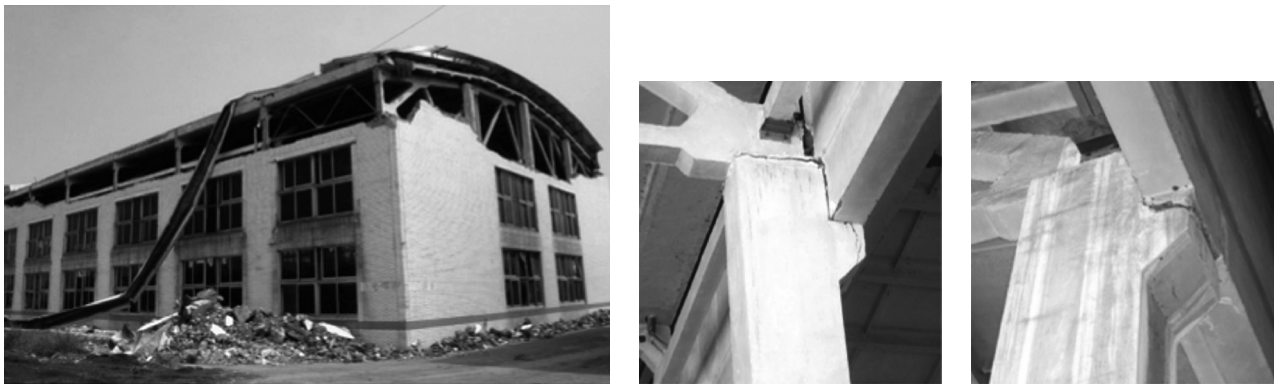
Fig. 4. *Damage and partial collapse of the Xiting Package Ltd. Factory complex in Mianzhu City, Wenchuan, China, (Zhaoa et al., 2009).*
Danno e parziale collasso del complesso industriale Xiting Package Ltd in Mianzhu City, Wenchuan, Cina (Zhaoa et al., 2009).

Also after the May 12nd, 2008 Wenchuan earthquake (China, M_W 7.9), industrial buildings and facilities, in the area near the fault rupture, were severely affected, as shown by Fig. 4 [Zhaoa et al., 2009].

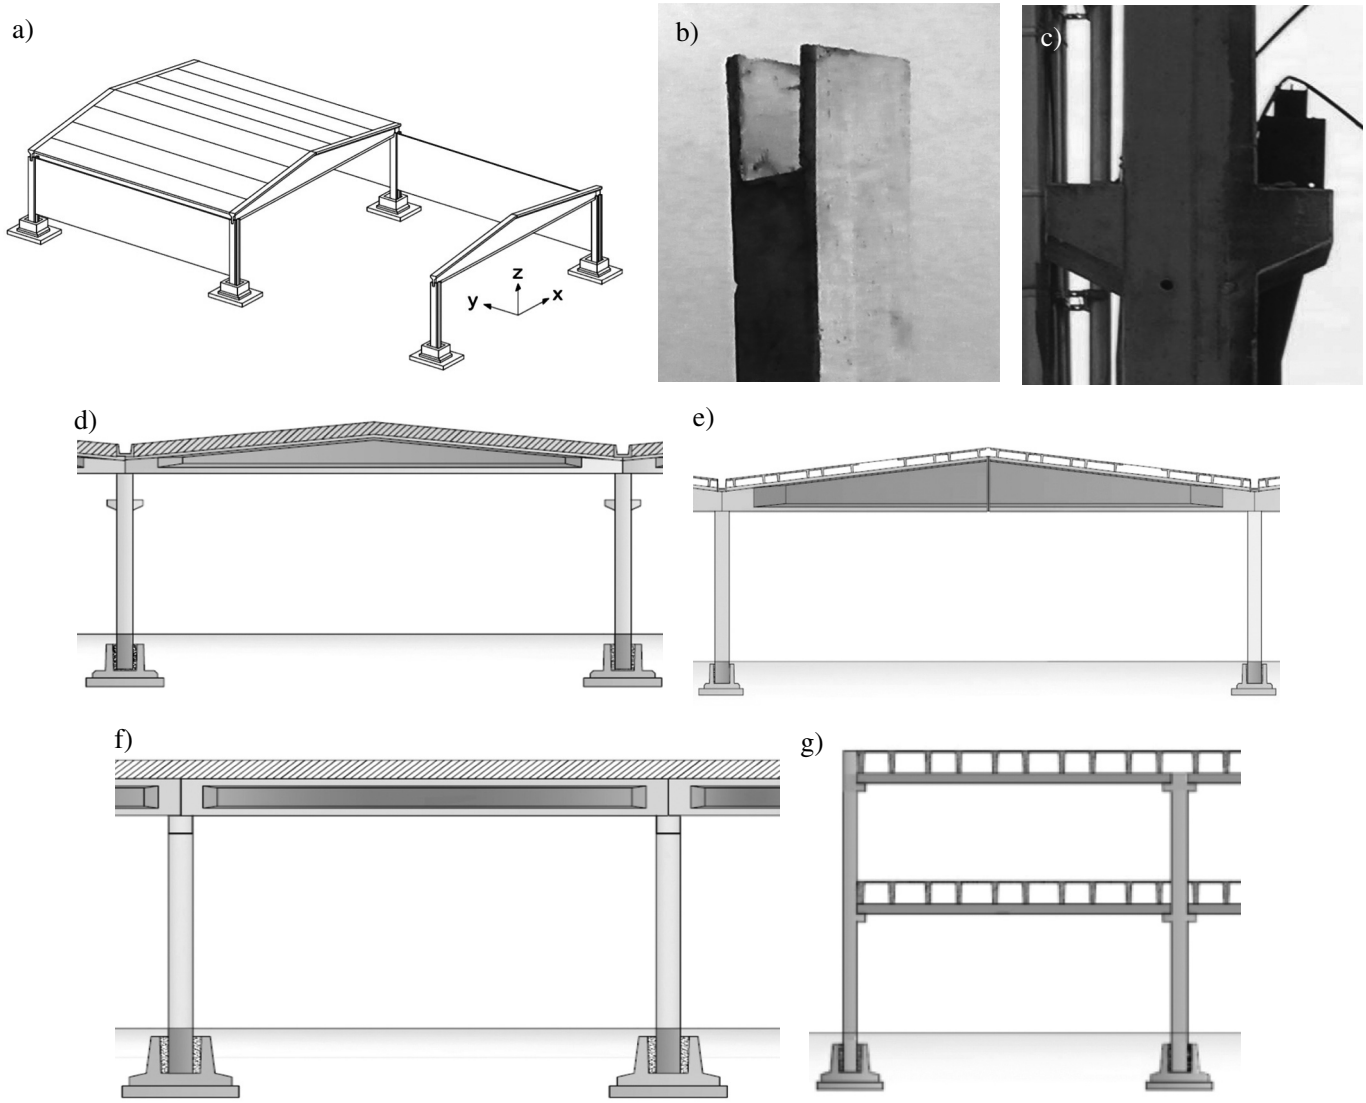
Fig. 6. *Typical resistant elements connections (a) and structural typologies (b-g) in the p/p. r.c industrial factories of Emilia-Romagna.*
Tipiche connessioni tra elementi resistenti (a) e tipologie strutturali (b-g) per edifici industriali prefabbricati dell'Emilia Romagna.

P/p. r.c. structures, located in Emilia-Romagna, are often built up with a precast system, which structural elements are made of prestressed concrete [Assobeton, 2012; Reluis, 2012], in simple or multi-storey buildings. The vertical structures consist in squared column fixed to the foundation (Fig. 6a), with various connection systems for the beam location, i.e. mainly: two forks at the top (Fig. 6b) or properly shaped horizontal supports (Fig. 6c). For the single-storey configuration, the horizontal structures are composed of: one- (Fig. 6d) or two- (Fig. 6e) segment symmetrically sloped beams; plain covering (Fig. 6f); for the multi-storey configuration, the horizontal intermediate floor is generally realised with alveolar panels or tiles completed with r.c. cast (Fig. 6g). The upper covering system is realized with tiles of different shape, also made with prestressed concrete (Fig. 7). Beam-tiles and beam-column connections are simply friction contacts. This type of constraint has been accepted for a non-seismic zone [Decree, 1987; Circular, 1989], according to the rules in force at the time of the construction of most of the existing factories (before 2003, as mentioned in the following section 4). Therefore, many current structures are not adequate to support seismic actions.

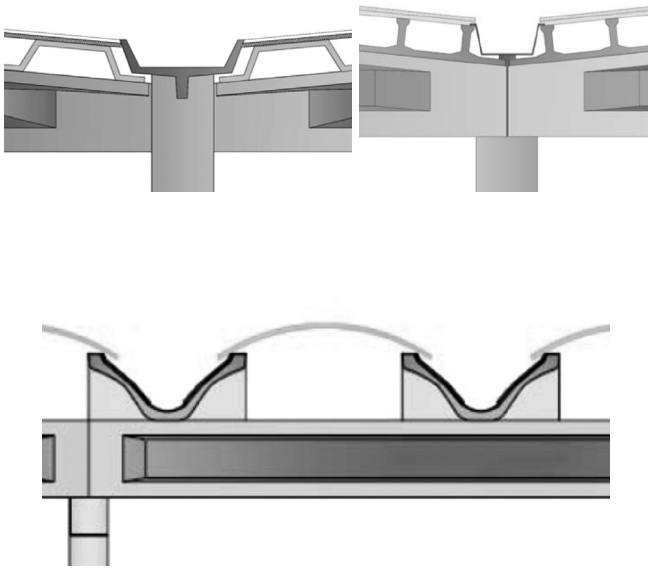
Fig. 7. *Covering typologies.*
Tipologie di coperture.

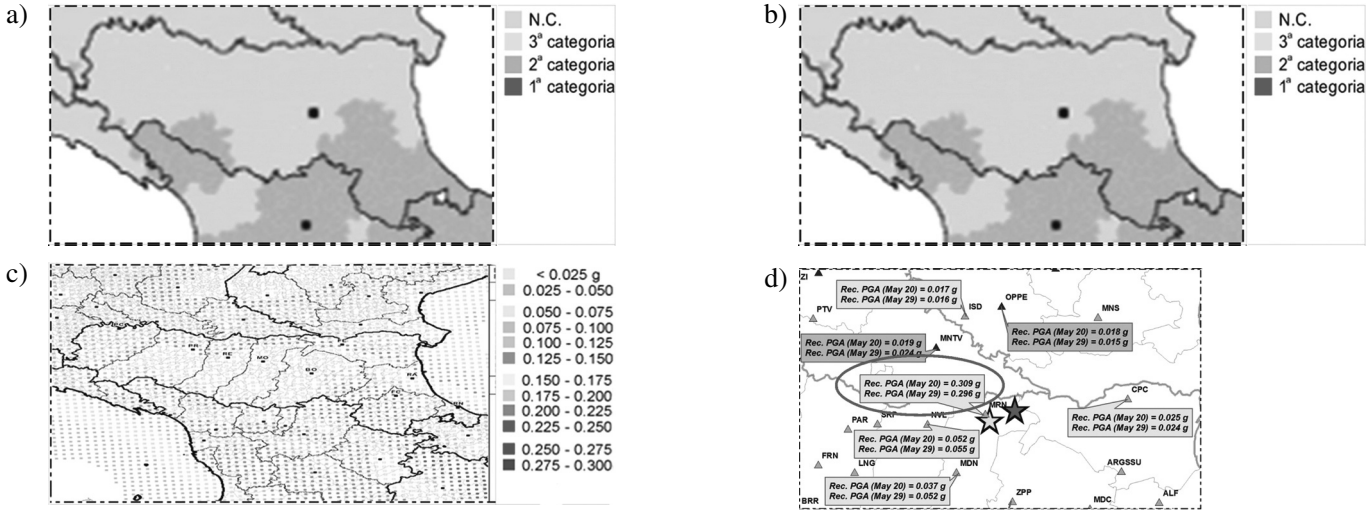
Fig. 14. *Evolution of seismic classification in Emilia-Romagna: a) Decree 1984; b) OPCM 3274, 2003; c) OPCM 3519, 2006; d) PGA related to the Emilia-Romagna seismic events.*
Evoluzione della classificazione sismica in Emilia Romagna: a) Decreto 1984; b) OPCM 3274, 2003; c) OPCM 3519, 2006; d) PGA associate agli eventi sismici dell'Emilia Romagna.

Until 2003, most of the Emilia-Romagna Region (including the affected area) was not classified as a seismic zone [Decree, 1984, see Fig. 14a], except a few municipalities located in the Apennines, although part of its territory had already been mentioned among "high seismic risk areas" [OMI 2788, 1998]. But after the tragedy occurred during the 2002 Molise-Puglia earthquake, when the collapse of the primary school in San Giuliano di Puglia killed 27 kids and their teacher [Indirli et al., 2004], the Italian seismic hazard classification (together with the seismic code) was finally updated [OPCM 3274, 2003] and most of Emilia-Romagna included in 3rd category; only the Forlì province ad a little part of the Reggio Emilia district were classified in 2nd category (Fig. 14b). Subsequently, the OPCM 3519 (2006) defined the seismic hazard map (Fig. 14c). It is worth noticing that the horizontal Peak Ground Acceleration (PGA) foreseen by the updated seismic hazard map [OPCM 3515, 2006] in the affected area of Emilia-Romagna is between 0.150-0.175g, while the maximum recorded PGA in Mirandola (Modena) is about 0.30g (Fig. 14d). Furthermore, significant vertical seismic actions has been also found; finally, the local amplification of seismic effects due to soft soil should be taken into account, foreseeing accurate microzoning campaigns.

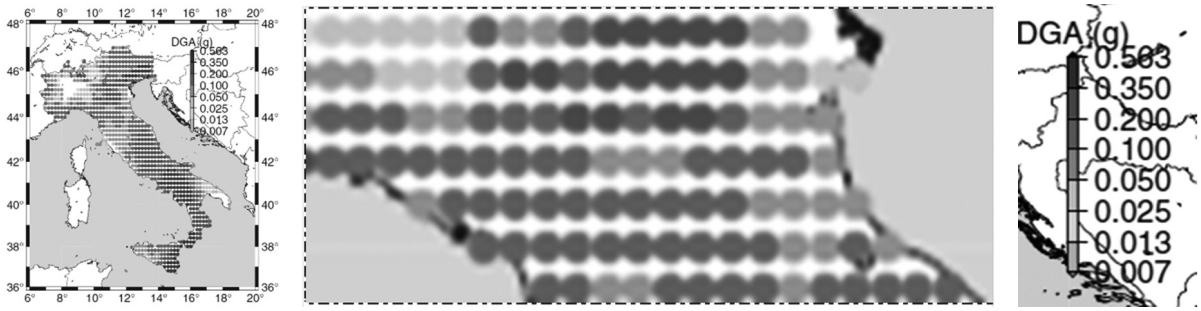
Fig. 15. *NDSHA Map for the Emilia-Romagna area.*
NDSHA mappa per la regione Emilia Romagna.

For the Emilia-Romagna Region, the NDSHA studies provided values of acceleration closer (with respect to PSHA) to those recorded in May-June 2012 (between 0.200-0.350g, see Fig. 15).

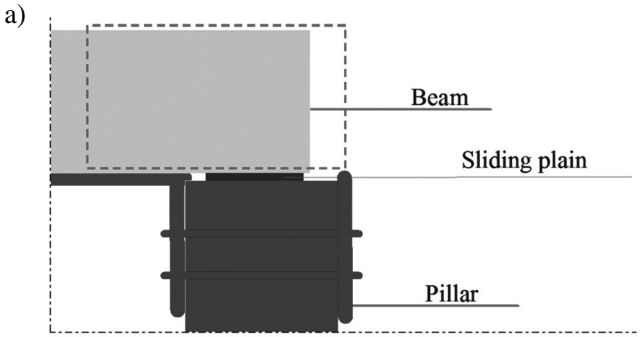
Fig. 16. *Deficiency due to inadequate connections among structural elements (DPC, 2012).*
Problemi conseguenti connessioni tra elementi strutturali non adeguate (DPC, 2012).

– deficiency due to inadequate connections among structural elements (Fig. 16);

All the structural elements (beams, columns, floors and foundations) should guarantee a box behaviour under the horizontal forces due to the earthquake. Friction connection is not allowed. The efficiency of precast linking system should be evaluated, while the resistant mechanism of the in situ casted r.c. connection systems involves both concrete and steel bars mechanical features. In the latter case, only the shear strength of the concrete can be considered, if the information about steel bars is absent. According to the dimension of the support, specific interventions should be realized in case of absent or inadequate shear resistant systems, aiming at the reduction of both beam-covering and beam-column relative displacements (see Fig. 6a). At this purpose, the realization of steel connection systems can be useful to upgrade or retrofit the support perform in case of both sliding and fix constraints, thanks to their easy and speed in execution. Sliding connections should be designed taken into account the main seismic displacement (Fig. 19). On the other case, the fix constraints should not lead additional significant moments to the connected parts (beam and column) because they are not designed to perform this stress. Therefore, a hinge constraint was also suggested at the column-beam connection (Fig. 20a,c). The consolidation of the column forks can be realized by means of steel elements, similarly, where it is required (Fig. 20b). The decrease of the permanent load can be useful in case of upgrading of the shear connection strength. Covering structures can be suspended to an *ad hoc* system. In addition, the reduction of relative displacements in x direction (column-beam, see again Fig. 6a) should be also realized. In any case, it is necessary to carry out shear connection elements. Finally, vertical connection between structural elements should be realized by considering the results of in situ inspections, if the vertical seismic component can produce relevant effects.

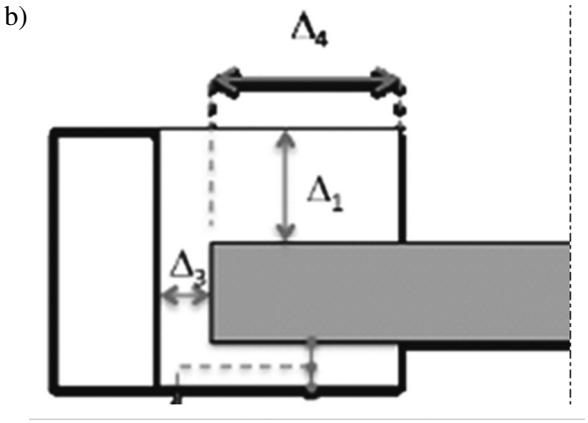
Fig. 19. *Sliding constraint; a) a practicable solution; b) sliding surface.*
Vincolo a scivolamento; a) una soluzione praticabile; b) superficie di scivolamento.
