THE PIANURA PADANA EMILIANA EARTHQUAKE

Behaviour of industrial buildings in the Pianura Padana Emiliana Earthquake

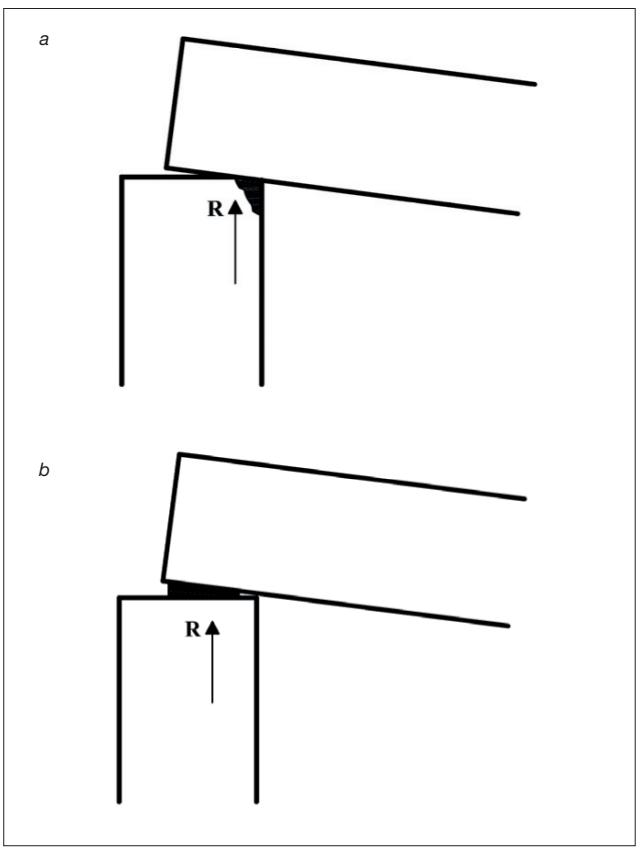
The bending rotation of the beam creates a stress concentration at the top of the pillar, with possible spalling of the concrete (Fig. 4a). This suggests the interposition of a bearing pad (Fig. 4b). If a horizontal force overcomes the friction force, the beam can lose its bearing. A steel dowel or a reinforcing bar can prevent this kind of collapse (Fig. 5).

FIGURE 4 Bending stresses and concrete spalling on the column, avoided by means of the interposition of bearing pads
Source: ENEA

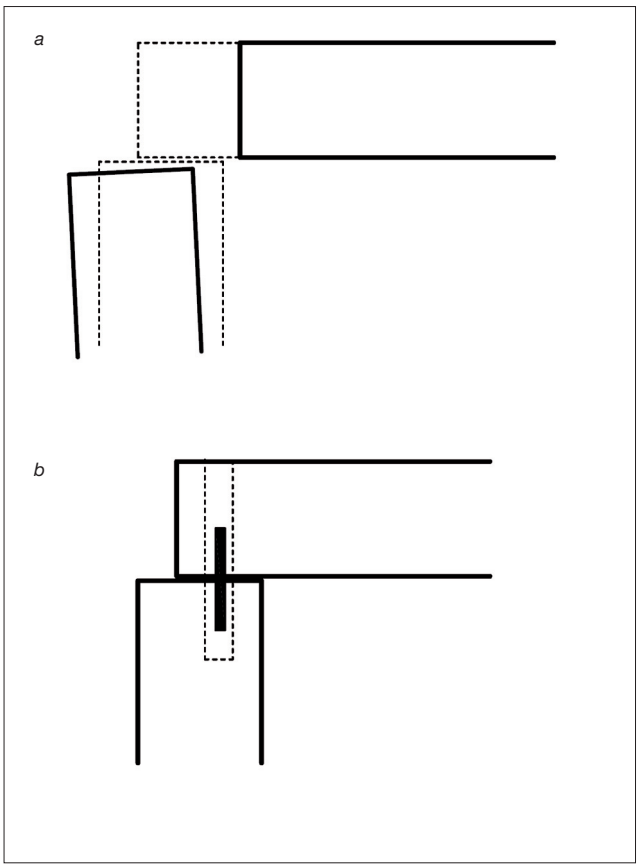
FIGURE 5 Possible relative displacement induced by external forces and insertion of a steel dowel to increase the shear resistance
Source: ENEA

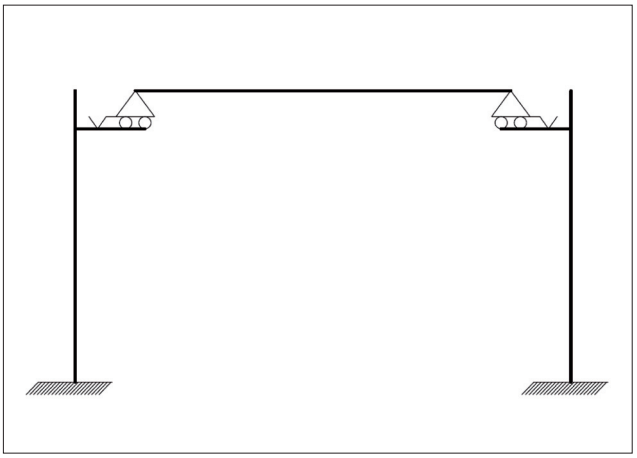
The observed damage in industrial buildings was mainly due to the following reasons: loss of bearing, pillar damage, collapse of external cladding panels, instability of steel shelves. Figs. 6 and 7 show some examples of loss of bearing. In many cases, the length of the bearing was too short to allow the beam-support relative motion under the seismic action. Each portal, from a structural point of view, can be depicted schematically as in Fig. 8, where the static equilibrium exists only if the horizontal forces acting on the beam do not overcome the friction forces.

FIGURE 8 Scheme of the simply supported beams with friction
Source: ENEA

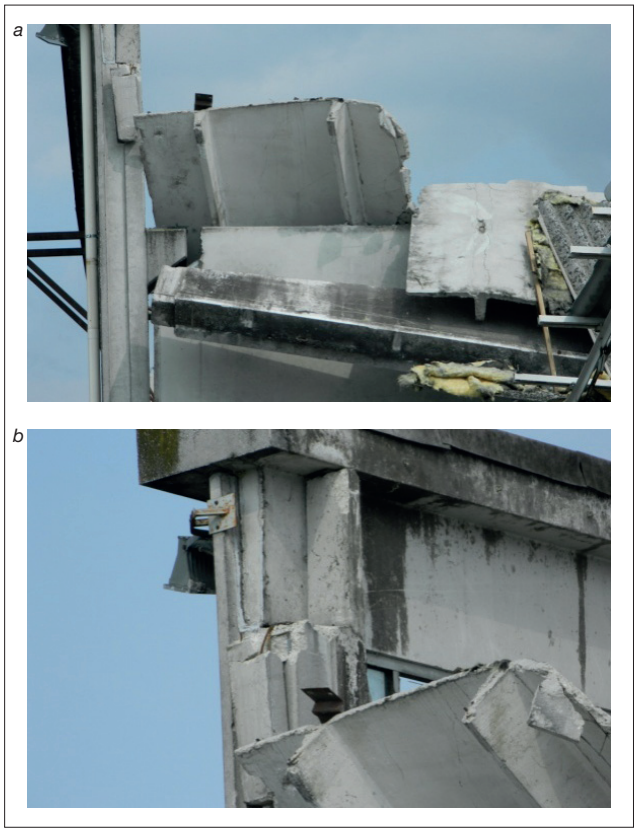
FIGURE 10 Lateral toppling of the beam
Source: ENEA

of the covering tiles, realising a tile/beam connection, effective in the seismic direction as a tying system.
In some cases the beam toppled down laterally, as shown in Fig. 10, after the failure of the lateral restraint present at the top of the columns, unable to resist to horizontal actions. Clearly, the failure mechanism depended also on the prevalent direction of the seismic motion. Different types of damage to columns are shown in Fig. 11.
Several collapses were related with non structural elements. In particular, shelves were often present in warehouse sheds, constructed by an assemblage of steel elements; they carried huge gravity loads.
Under horizontal actions, such as those due to seismic excitations, these inadequately braced structures exhibited instability (Fig. 12a). When the shelves were part of the structure (Fig. 12b), the evaluation of second order effects in the design phase is certainly significant.

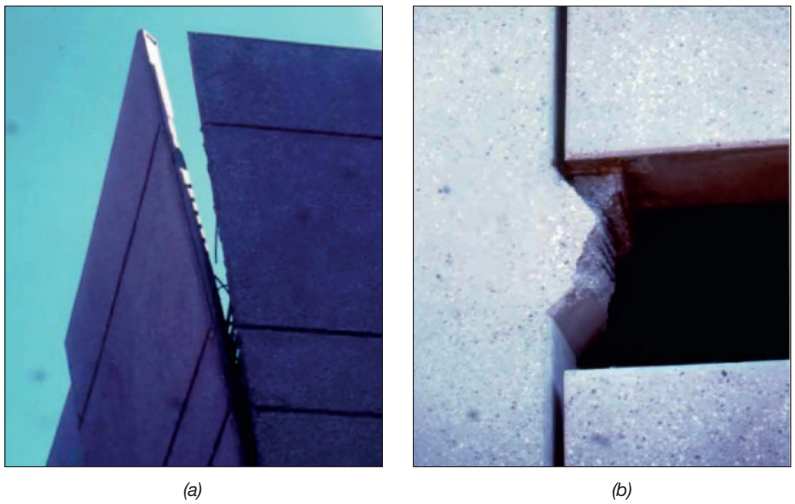
FIGURE 15
Cigna Garage damaged by the 1994 Northridge earthquake [7]

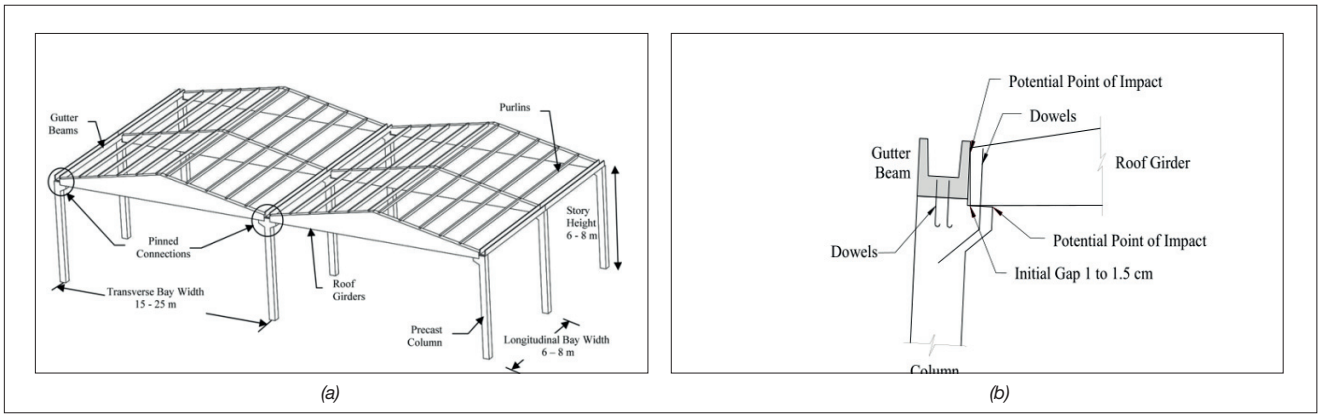
FIGURE 16 A Turkish typical configuration of one storey precast construction near Kocaeli and details [11-14]

Some typical one-storey industrial pre-cast structures (Fig. 16), located in the epicentre area of the August 17th, 1999, Kokaeli earthquake (Turkey, M_W=7.4), didn't show good results, while others remained undamaged (Fig. 17) [10].

The collapse was mainly due to poor design, detailing, and construction, leading to the lack of diaphragm action caused by the inadequate connections (pinned or dowel, simple to realize by the prefabricators) between columns and beams. In addition, buildings under construction were susceptible to collapse when the roof girders rotated off their supports.

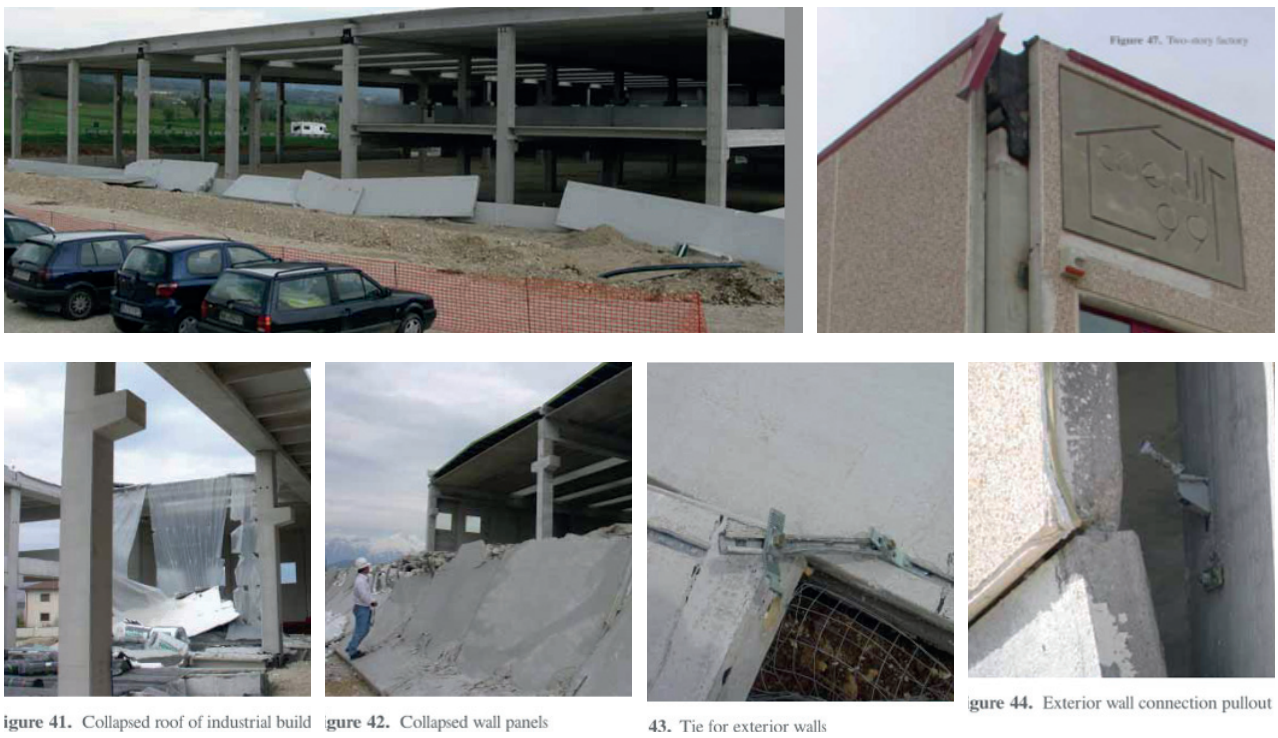
FIGURE 19 Collapse due to lack of adequate anchoring in p/p. r.c. structures in L'Aquila [17]

existing seismic classification of the area before the event, the level of damage was surprising (Fig. 19).
