Bulletin of the New Zealand Society for Earthquake Engineering, Vol. 50, No. 2, June 2017

PERFORMANCE OF WINERY FACILITIES DURING THE 14 NOVEMBER 2016 KAIKŌURA EARTHQUAKE

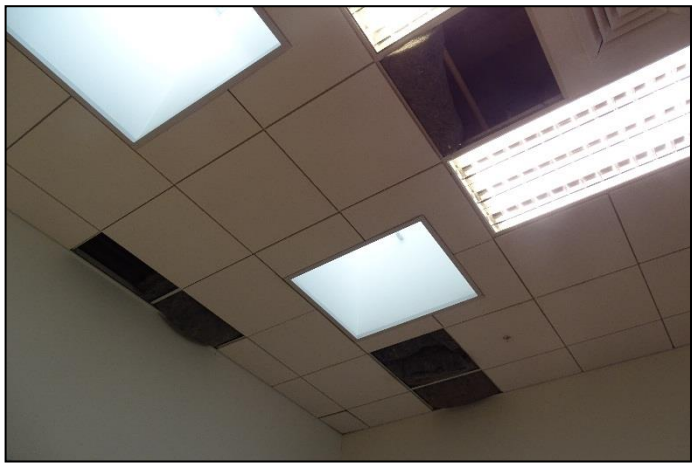
Figure 3: Performance of buildings housing winery facilities showing minimal damage (0.20g hPGA).

Buildings housing winery facilities generally performed well, with minimal sustained damage. A large number of buildings were of tilt-up panel type construction with minor damage observed as shown in Figure 3. The observed damage appeared to be mostly associated with panel connections and fixtures, rather than extensive damage to panels themselves, which is similar to observations following the 2010/11 Canterbury earthquakes [19]. Minor cracking was also observed in some foundation pads, especially at wineries located near the East coast where accelerations were considerably higher than in the Blenheim area. Non-structural damage that was typically observed included loss of ceiling panels in office spaces (see Figure 3e). Further observations of non-structural damage sustained in the 2016 Kaikōura earthquake are reported by Furner et al. [20].

(a) Precast panels exhibiting movement that required temporary propping

(b) Concrete panels performed well, minor observed cracking at the base

(c) Cracking observed near wall base and at panel joints

(d) No damage or residual movement observed at concrete panel joints

(e) Non-structural damage of ceiling panels in office spaces

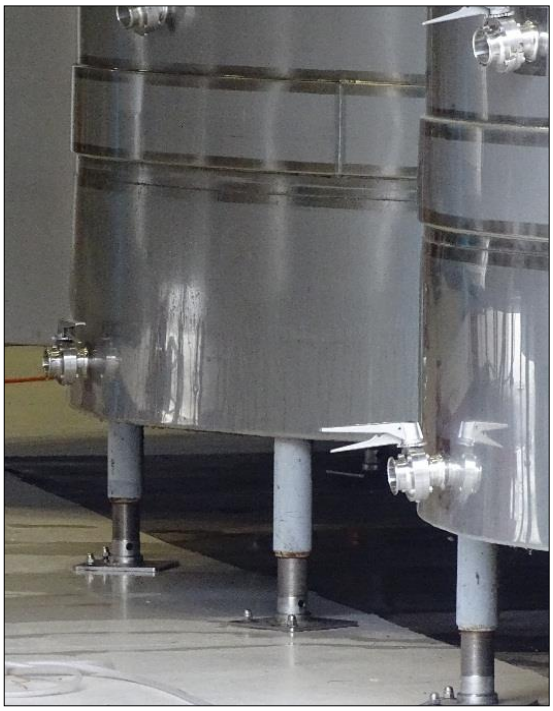
Figure 4: Damage to legs and base plates of legged stainless steel tanks.

- Legged tanks with tall bases typically had braced legs. The braces were often connected to the legs 200-300 mm above ground with the unbraced portion of the leg commonly failing in bending (see Figure 4a).

- Pull-out of adhesive anchoring systems used to secure tank base plates was widely observed (see Figure 4b). It was evident that fixing of base plates reduced the horizontal translation of the tanks but dramatically increased the forces in the tank legs.

(a) Bending of tank legs below brace, with tank temporarily supported on timber blocks (0.13g hPGA)

(b) Significant movement and uplift of legged base plate with bending of the leg member below bracing (0.20g hPGA)

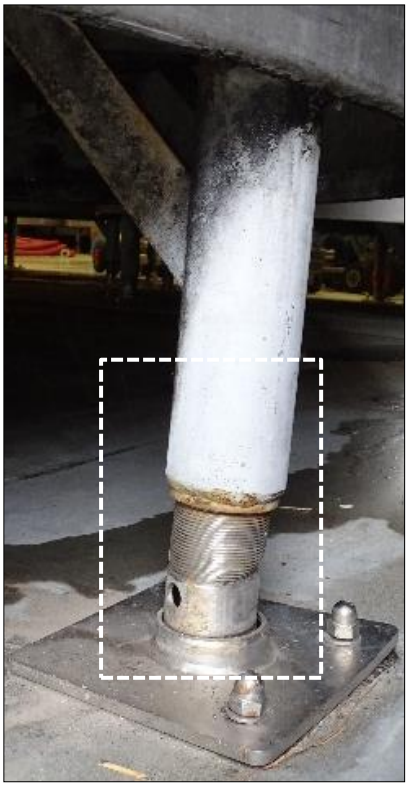
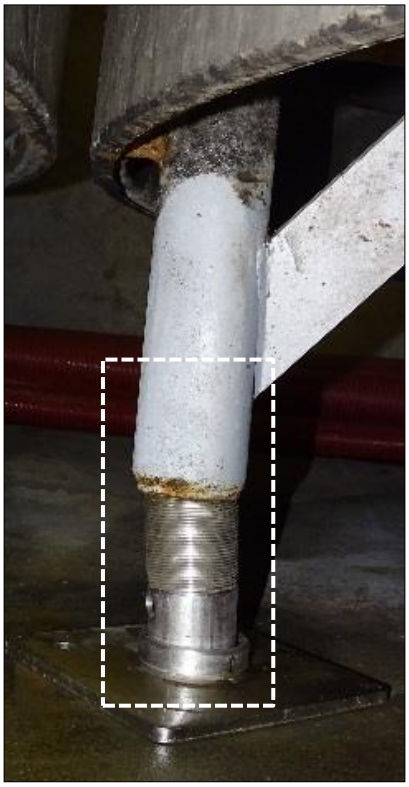
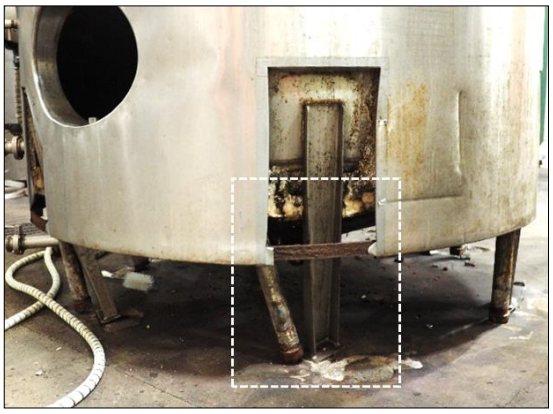
Figure 5: Damage to leg supports of legged stainless steel tanks.

- Failure at the top of the leg in unbraced frames, (1) within the supporting beam, or (2) fracture of the weld connecting the leg and beam at the maximum moment locations. The weld connecting the leg and beam is often poorly detailed (see Figure 5b).

- Local buckling of adjustable threaded leg sections at the point of cross-section reduction (see Figure 5a) or where the thread engagement length was insufficient, resulting in an inadequate bending moment transfer mechanism (see Figure 5c-e).

(a) Slender adjustable legs prone to buckling at the point of cross-section reduction (0.20g hPGA)

(b) Collapse of tanks due to buckling of slender and understrength support legs (0.13g hPGA)

(c) Buckling of adjustable portion of the leg support and bending of base plate (0.20g hPGA)

(d) Buckling of adjustable leg support portion (0.20g hPGA)

(e) Buckling of adjustable portion of the leg support below brace (0.20g hPGA)

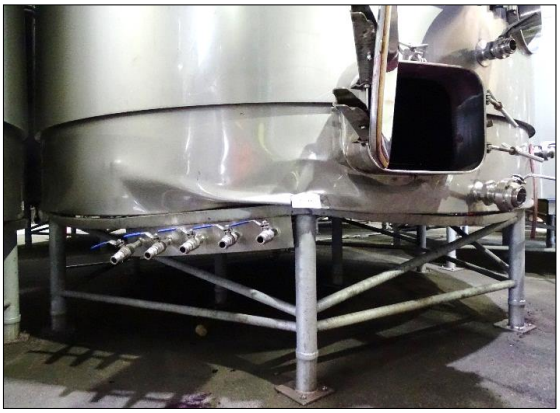
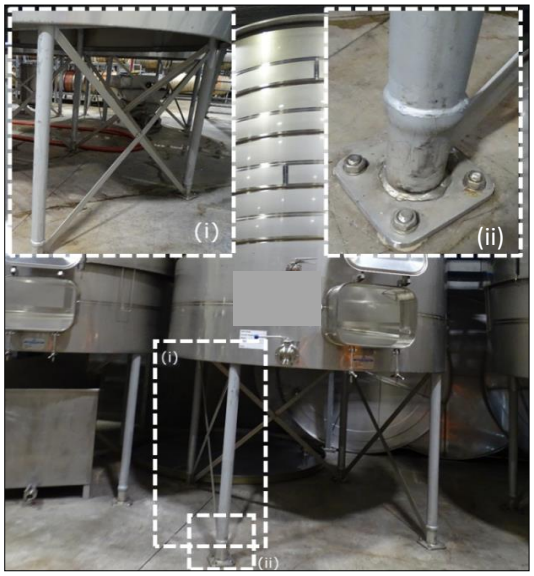
Figure 6: Poor performance of retrofitted legged tanks.

- Inadequate strengthening of tank legs (see Figure 6a).
- In cases where the legs were adequately strengthened, buckling and damage to tank skirts occurred (see Figure 6b).
- Well braced legged tanks with braces connected to the bottom-most part of the leg generally had no damage to legs or tanks (see Figure 7a,c,d).
- Tanks with stiff squat legs that were not secured to the concrete slabs generally performed well, with only minor evidence of sliding on the concrete slab (see Figure 7b) or minor damage due to pounding with adjacent tanks.

(a) Additional legs added following the 2013 earthquakes (see white dotted box). Torsional rotation observed with near collapse of the tank (0.14g hPGA)

(b) Strong braced legs fixed to concrete slab resulted in good performance of the legged system but lead to buckling and damage to the tank above (0.23g hPGA)

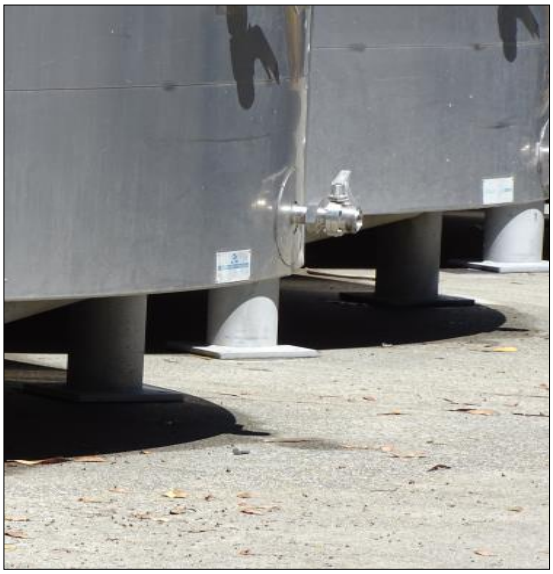
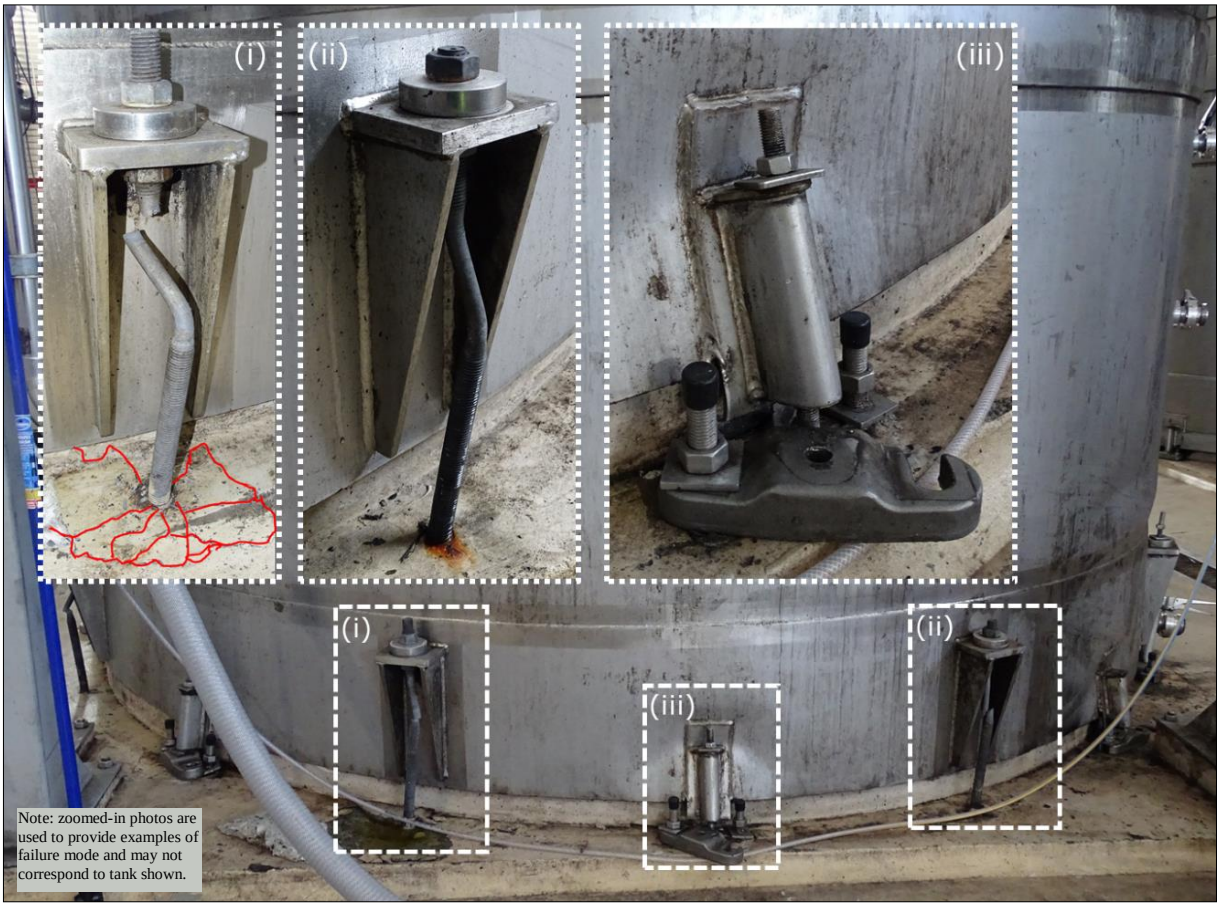
Figure 7: Good performance observed for well-designed legged stainless steel tanks.

(a) No damage to legs or tanks observed (0.20g hPGA), (i) braces connected near base plate, (ii) base plate well connected to concrete

(b) Tanks with squat legs not fixed to the concrete slab – no evidence of significant movement or damage but in some cases translation of 10-20 millimetres (0.14g hPGA)

(c) Example of well braced and strong design with minimal/no damage observed (0.23g hPGA). Some of these braced tanks had lower wall fracture, with likely loss of wine, but most performed well

(d) Example of well braced tank with minimal/no damage observed (0.13g hPGA). Some braced tanks had damage to the lower part of the tank wall, with likely loss of wine, but most performed well

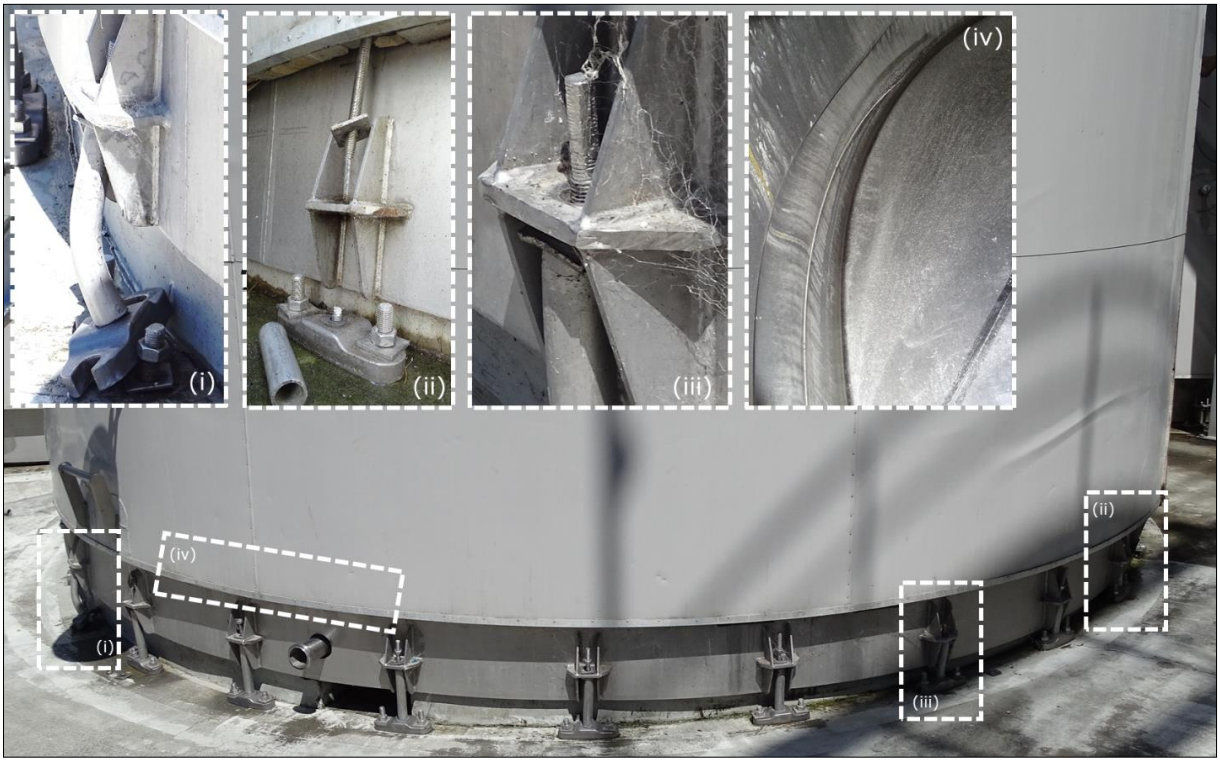
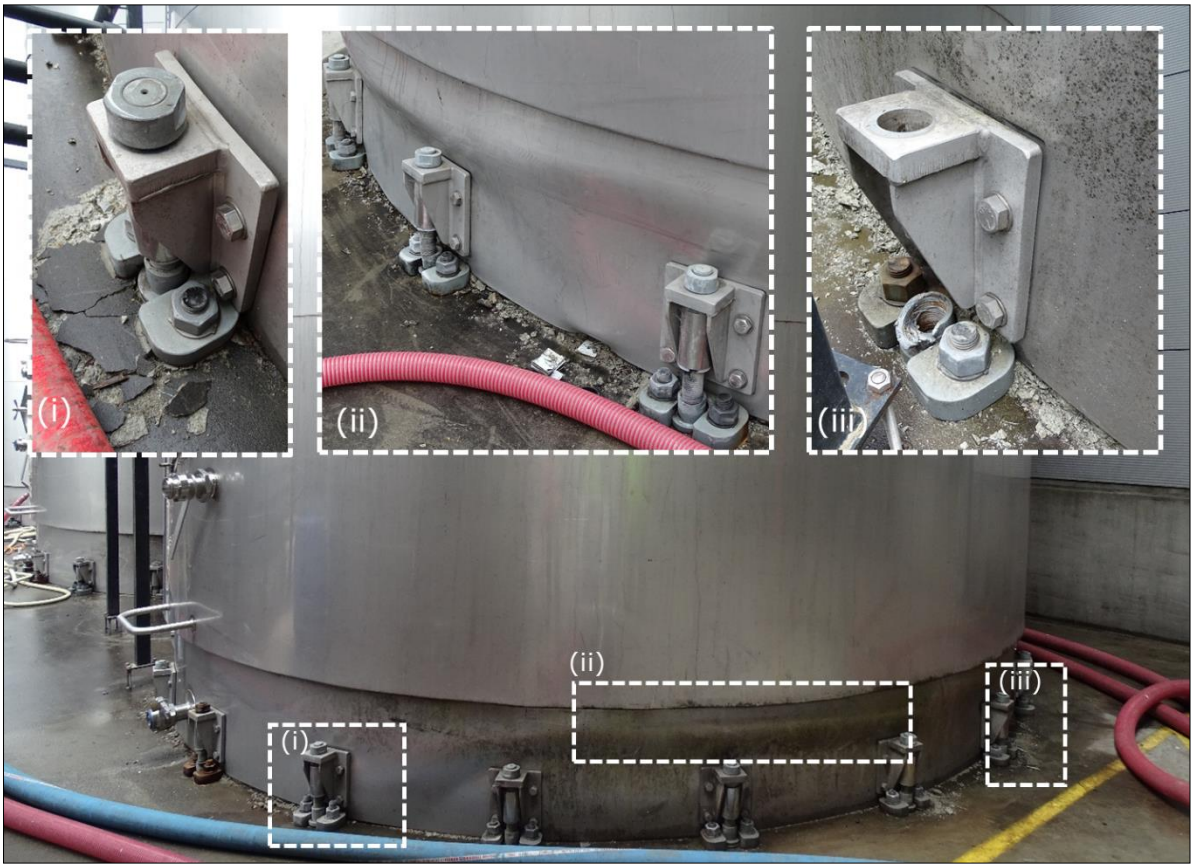
Figure 8: Damage observations to anchorage systems of flat-bedded stainless steel tanks.

(a) Use of mixed anchor systems resulting in pull-out of anchors from concrete and yielding, rupture and compression failures of anchor rods, resulting in major damage to the base of the tank (0.13g hPGA)

(b) 150 kL tank showing damage to anchoring connections and tank base; (i) buckling of the anchor rod and dislodgement from anchoring bolts; (ii) rupture of anchor rod; (iii) stripped thread and fully coming off the holding nut; (iv) evidence of tank base distortion in 'knuckle-squash' type deformation (0.13g hPGA)

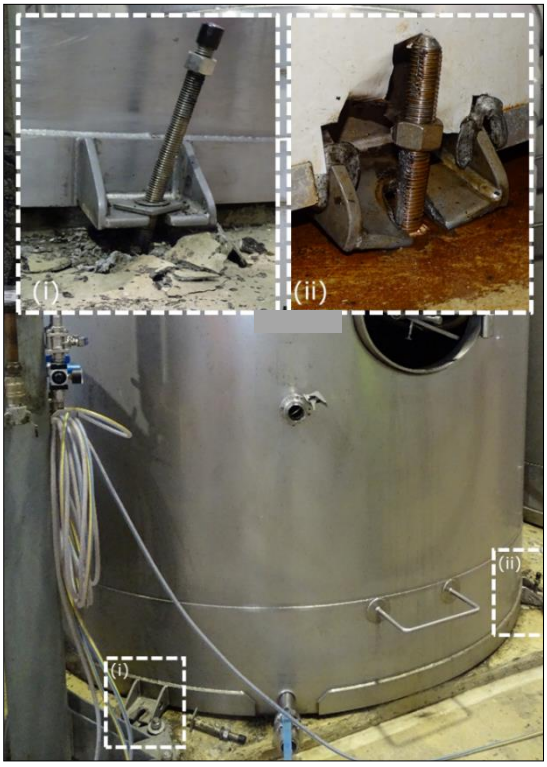
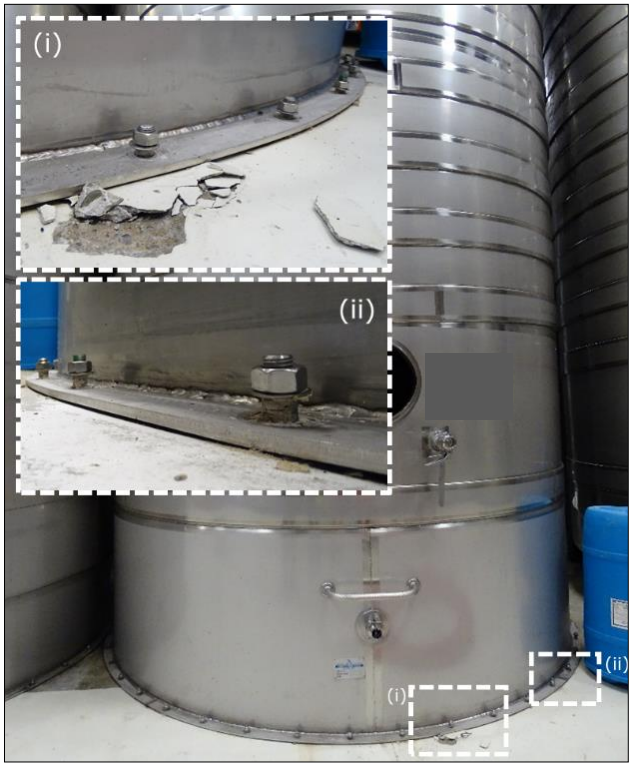
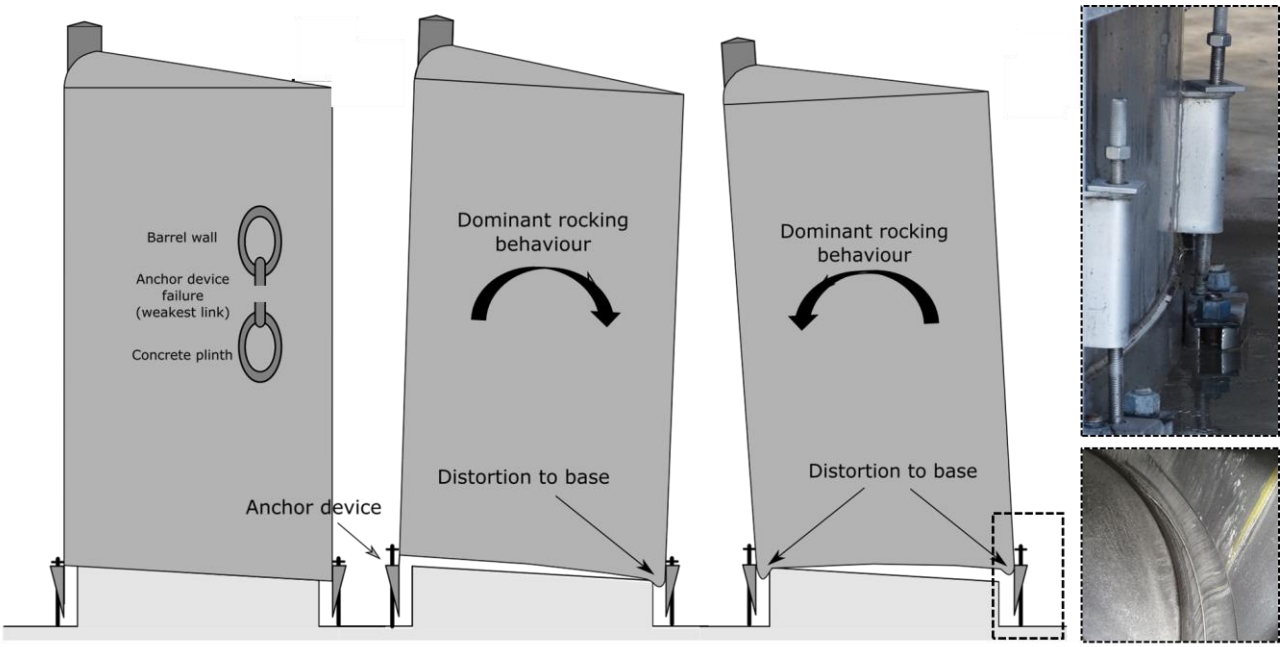
Figure 9: Damage observations to anchorage systems in flat-bedded stainless steel tanks.

(a) 240 kL tank showing various forms of damage to anchors and base skirt (0.23g hPGA)

(b) Failure at threaded rod/adhesive interface indicating poor workmanship of adhesive installation (0.13g hPGA)

(c) Stripped thread and bolt pull-out from concrete floor (45 kL tanks) (0.20g hPGA)

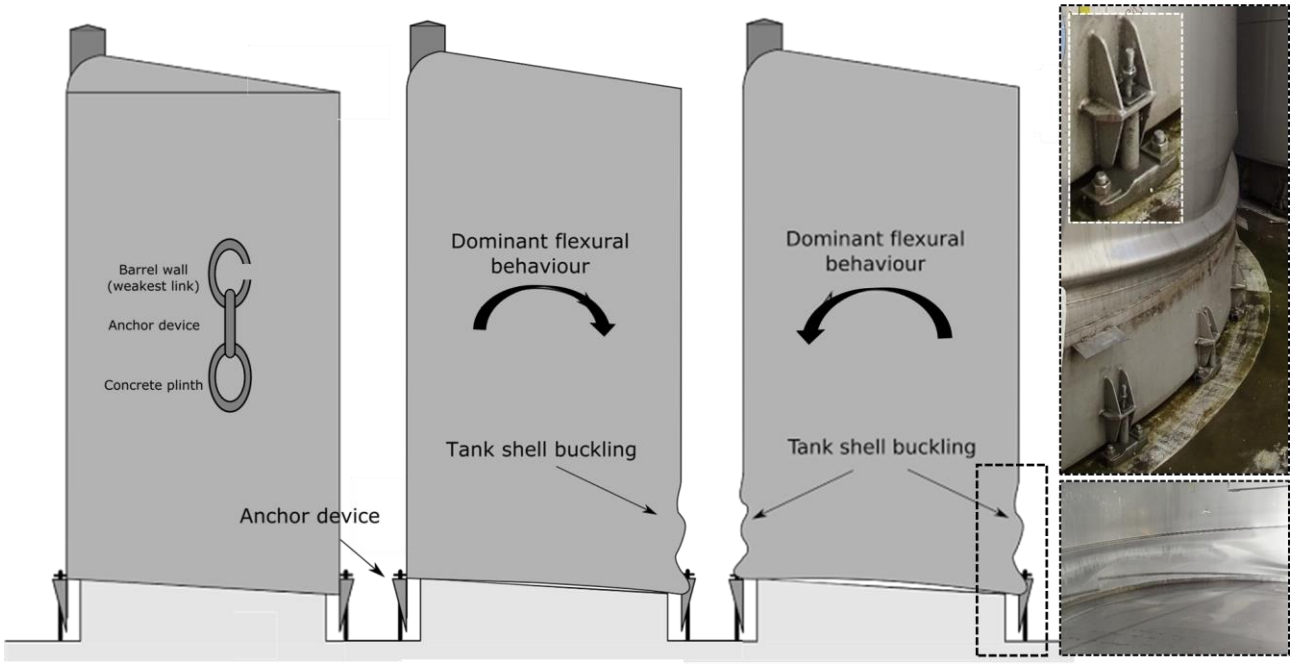
Figure 10: Schematics and photographic examples of flat-bedded tank modes of failure.

- Local deformation of the thin stainless steel layer due to rocking and horizontal displacement of the tanks (as shown schematically in Figure 10b with examples in Figure 15).

(a) Schematics and photographic examples of flat-bedded tanks with anchor devices

(*b) Schematics and photographic examples of flat-bedded tanks with tank shell buckling*

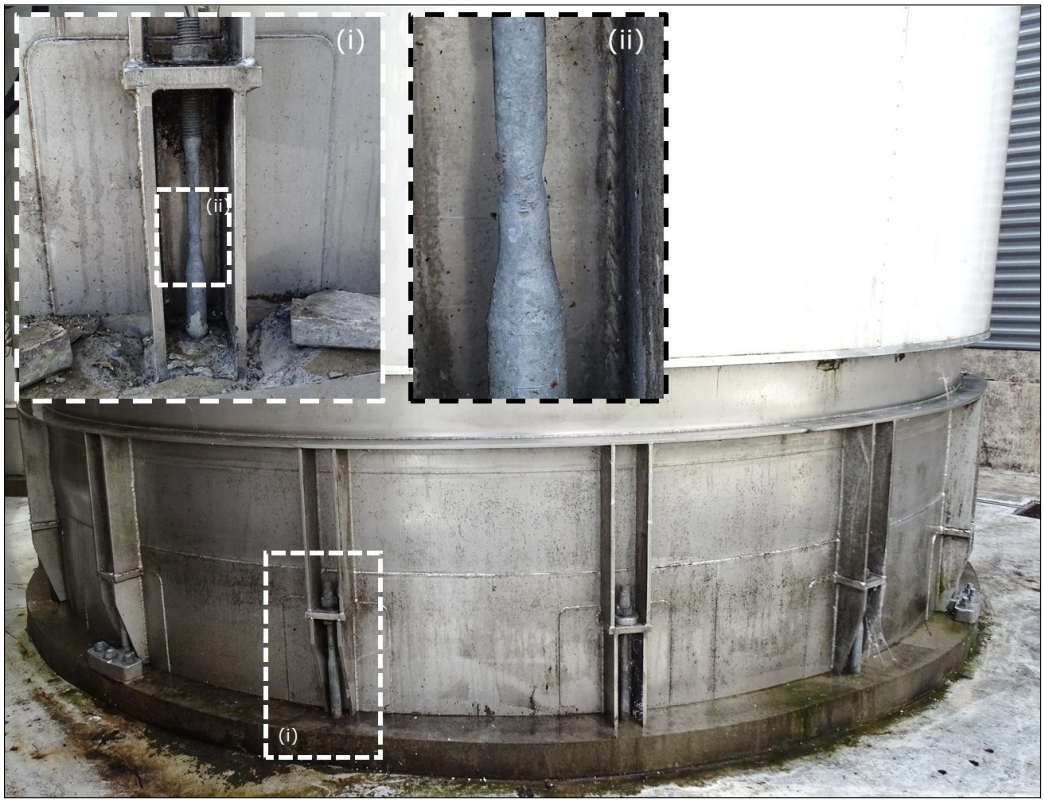
Figure 11: Tank skirting strengthened using extra welded stiffeners and addition of a concrete nib following the 2013 earthquakes; (i) close-up of the anchor connections showing crushing and spalling of concrete at base; (ii) close-up view of cup-and-cone yielding of the fuse rod (0.13g hPGA).

- Adding a skirt extension, or pouring a concrete nib up to the base of the skirt to provide solid bearing for the skirt and prevent knuckle deformation (see Figure 11), was observed to generally work well, although in some cases this intervention transferred failure to a different mechanism. The concrete nib was often observed to crack, particularly where it extends higher than the base of the skirt and encases anchor chairs.
- In some cases additional anchors were added. Additional anchors often resulted in the anchorage being stronger than the tank wall, leading to tank wall buckling.

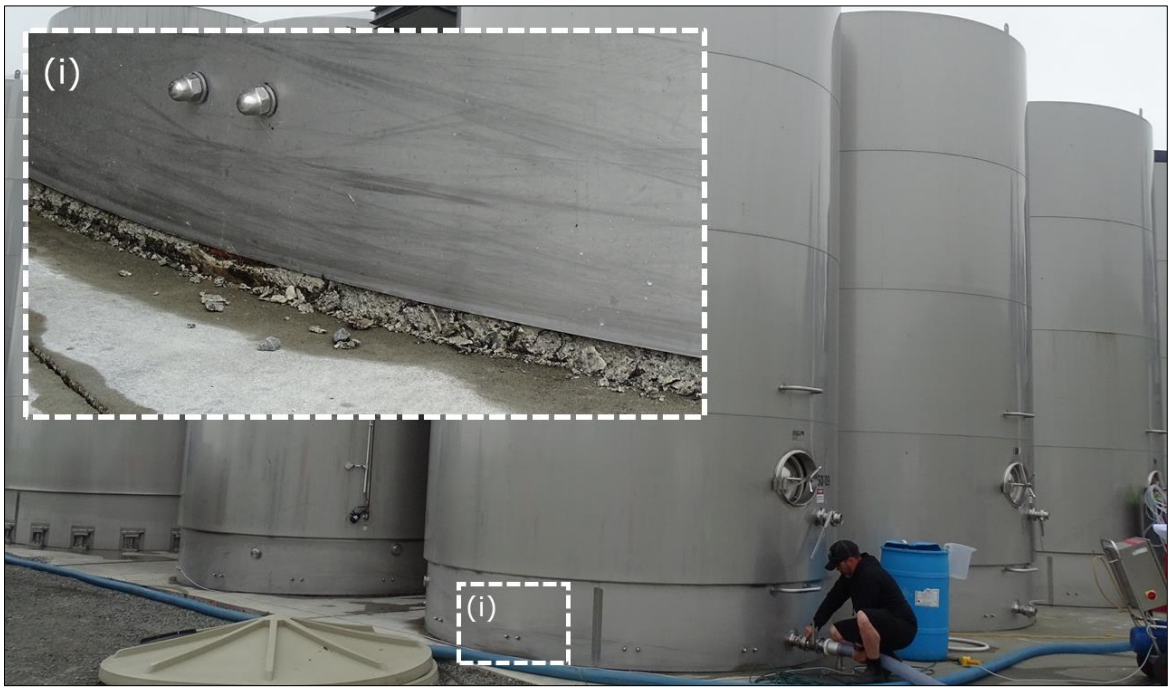
Figure 13: Examples of observed performance of anchor systems in flat-bedded tanks.

- Anchor bolt connections through the skirt into the concrete plinth were commonly observed to fail in shear (see Figure 13c).
- There were cases where flat-bedded tanks supported on plinths performed well, with no apparent damage (see Figures 11, 12, 13a-b).

(a) 120 kL tank with no evidence of damage due to good anchor performance (0.20g hPGA)

(b) 240 kL capacity tanks with no damage (0.23g hPGA)

(c) Flat-bedded tanks showing buckling near tank base and shear failure of anchor connections (0.14g hPGA)

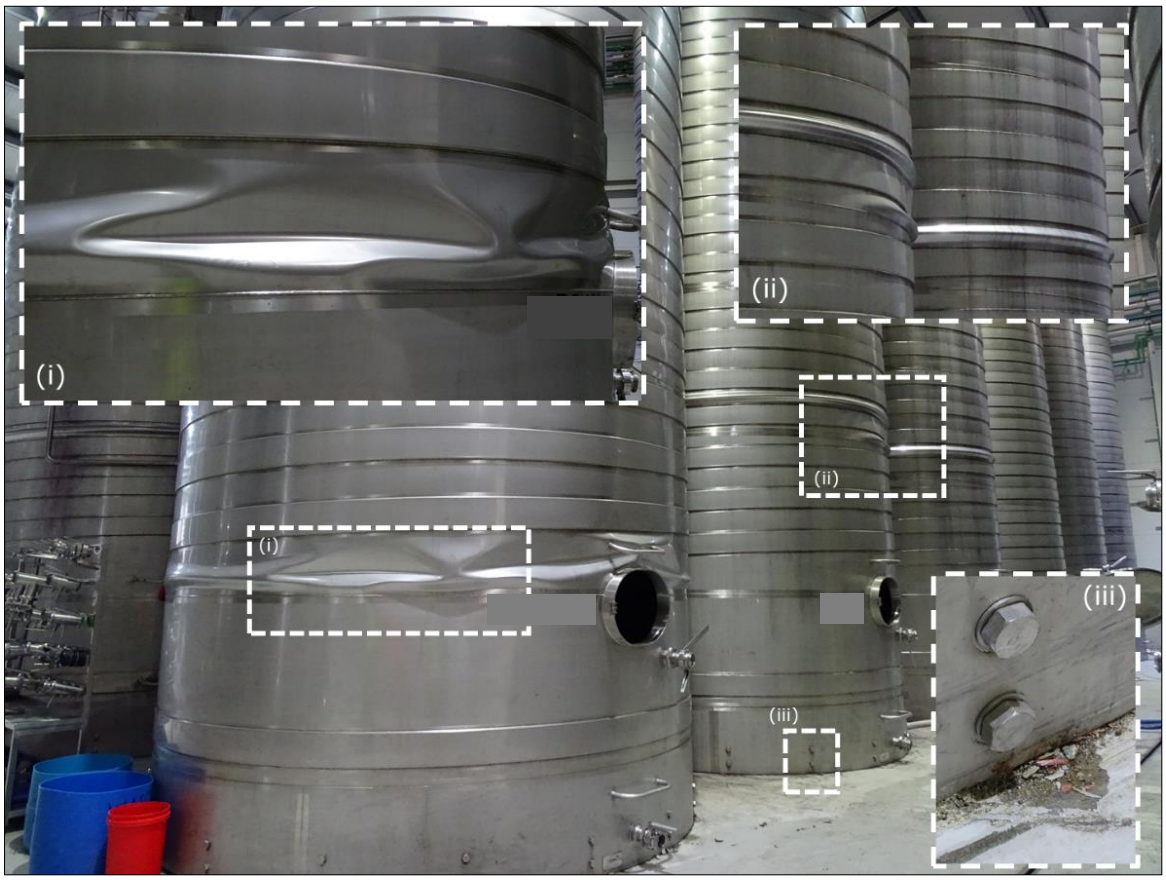
Figure 14: Observed examples of concrete spalling damage near tank skirt and diamond buckling damage in flat-bedded stainless steel tanks.

Diamond buckling refers to steel membrane compression buckling of the tank shell. This deformation mechanism was commonly observed in tanks with capacities over 100,000 L (see Figures 14b, 15a-b). Diamond buckling was mainly observed near the bottom of the tank wall. It is hypothesised that refrigeration channels restrain diamond buckling higher up the tank wall because the height of the 'diamonds' typically exceeded the height between adjacent refrigeration channels. It was observed that diamond buckling typically formed where no refrigeration channels were present, which is approximately over the lower 1.0 m height of the wall. Some cases were observed following the 2016 Kaikōura earthquake where this local buckling mechanism caused tank perforation and consequently wine loss.

(a) 60 kL tanks with minor evidence of concrete spalling (0.20g hPGA). Note that upon cutting away the skirting for closer inspection, some of the base connections were observed by others to be fractured

(b) Minor damage to base connections and observed diamond buckling of the tanks at varying heights (0.23g hPGA). Note that some of the base connections were observed by others to be fractured

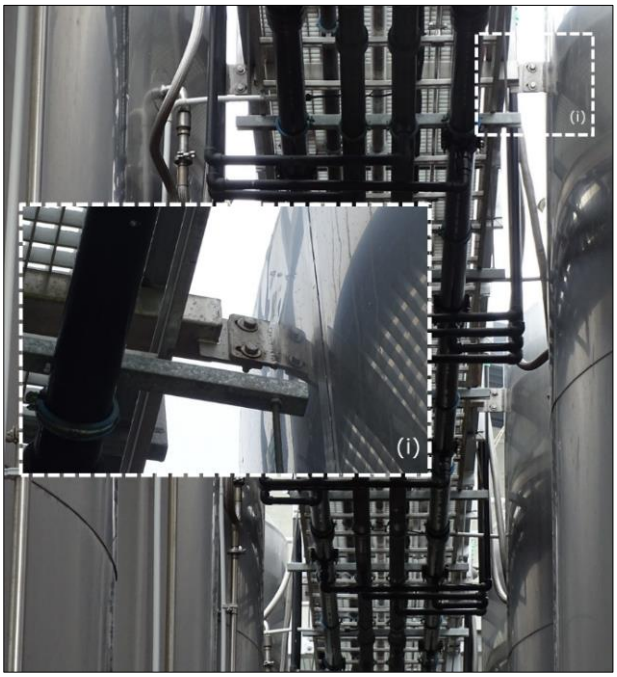
Figure 19: Performance of tank suspended catwalks.

(a) Damage to catwalk connection due to tank movement

(b) No damage observed in 60 kL tanks where catwalks were well secured at base

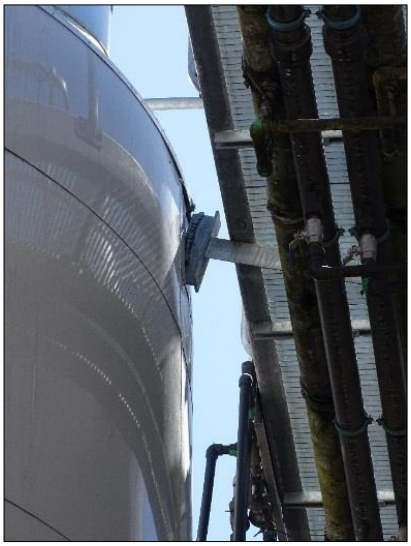
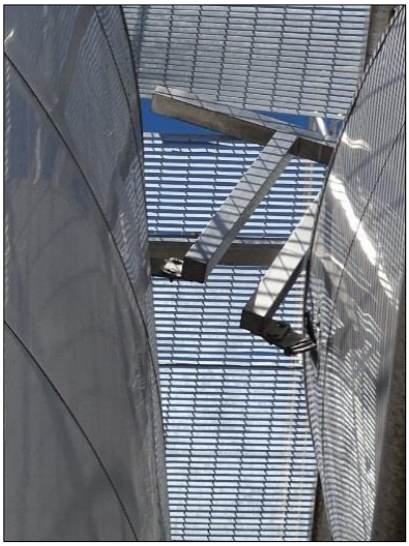
(a) Tank damage from catwalk punching

(b) Significant bending of catwalk connections

(c) Detachment of catwalk connections

(d) Tank top cone damage due to catwalk

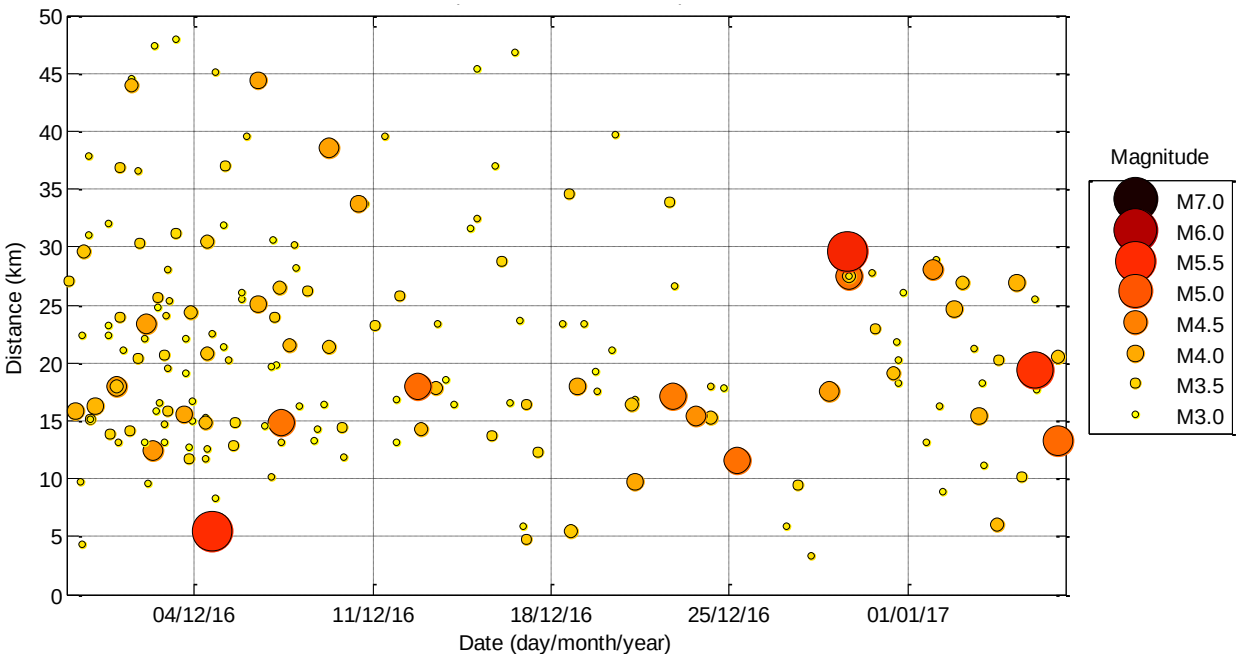
Figure 21: Magnitude of aftershocks within 50 km of Seddon, Marlborough, during the monitoring of winery facilities (from 28/11/16 to 07/01/17).

In total, there were approximately 480 separate aftershocks of a magnitude greater than M_W 3.0 in the Marlborough region during the monitoring period. Earthquakes located within 50 km of Seddon during the monitoring period are plotted in Figure 21. The accelerometers recorded at least 40 aftershock events that resulted in medium to significant levels of observed shaking to various winery structures. The largest recorded excitation was during a M_W5.49 earthquake on 4 December 2016, which was located less than 10 km from many instrumented storage tanks. During this M_W5.49 event, the recorded accelerations revealed significant amplifications in acceleration response up the height of many storage tanks. For example, the peak recorded accelerations at the base and top of an instrumented tank (175 kL capacity) were 0.032g and 0.514g respectively in the horizontal direction and 0.128g and 0.323g respectively in the vertical direction, as illustrated in Figure 22. An in-depth analysis of the recorded data is currently being conducted to investigate the true dynamic response of tanks of varying capacities and different anchorage systems. These results will be published in the near future and will include correlations between instrumented data and observed damage.

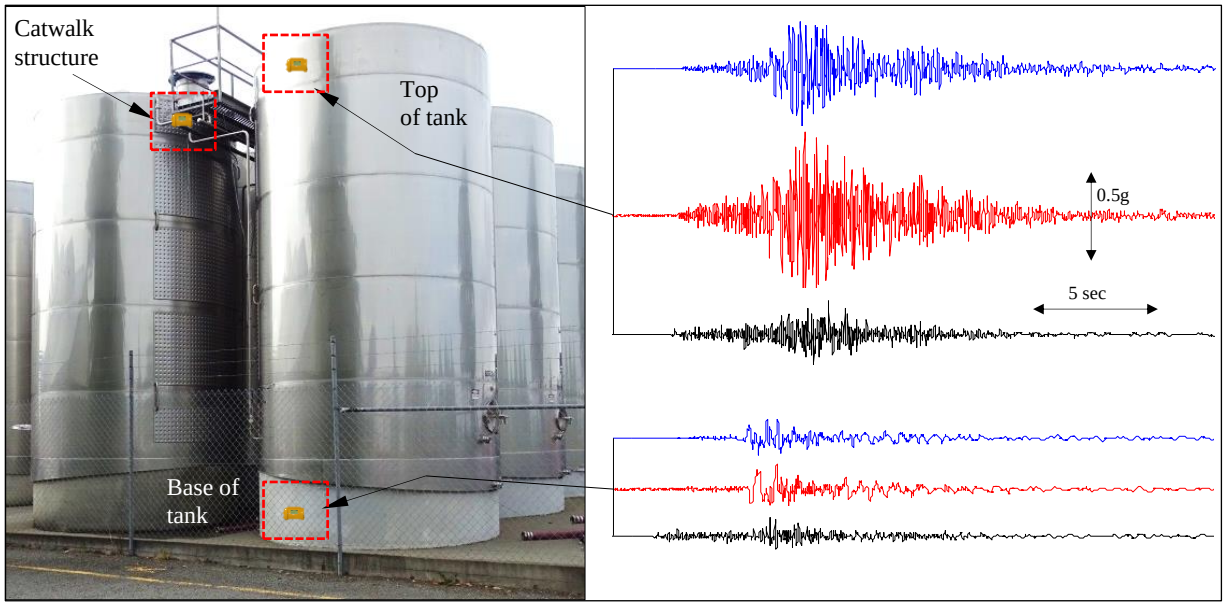
Accelerometer devices were securely mounted near the base and top of six different sized storage tanks; with tank capacities (in kL) of 40, 100, 120, 150, 175 and 240. Additional accelerometers were mounted onto catwalk platforms and at the roof height of winery buildings to record the performance of other structural components commonly found throughout a winery. Data was continuously collected from 28 November 2016 to 7 January 2017.
